**STRUCTURAL INTEGRITY
RESERVE STUDY
30-Year Projection
Beginning January 1, 2025**

Example SIRS Report

01 - Example SIRS Report
January 1, 2025

SIRS Report Introduction
Structural Integrity Reserve Study (SIRS)

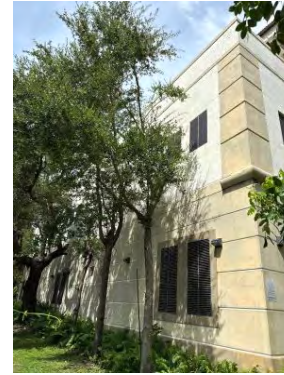
| Location | Desc. | Condition | Service Date | Replace Date | Rem Life | Adj Life | Quantity | Current Cost | Future Cost |
|---|---|---|---|---|---|---|---|---|---|
| Building | | Good | 07/01/2009 | 07/01/2059 | 34:06 | 50:00 | 1 | 10,000.00 | 32,767.41 |

Concrete Frame - Repair allowance for concrete. The structural framework of the building comprises load-bearing cast-in-place concrete elements with reinforced concrete decks supported by concrete shear walls and columns. The exterior walls consist of stucco-covered concrete masonry unit (CMU) block infill. This type of structural system typically has a lifespan of 100 years or more with proper maintenance and repair.

Over time, localized deterioration is common, requiring periodic maintenance. During our site visits, no significant damage or deterioration was observed. However, minor hairline cracking was noted on the exterior of the lake building. To address ongoing maintenance needs, a reserve fund has been included for periodic repairs to the cast-in-place concrete structural elements.

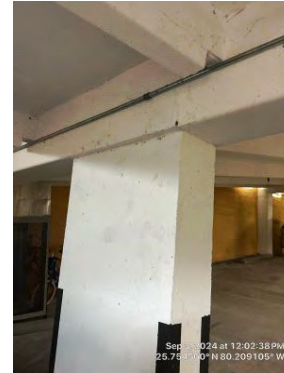
| Location | Desc. | Condition | Service Date | Replace Date | Rem Life | Adj Life | Quantity | Current Cost | Future Cost |
|---|---|---|---|---|---|---|---|---|---|
| Building | | Good | 07/01/2009 | 07/01/2059 | 34:06 | 50:00 | 1 | 0.01 | 0.03 |

Structural posts and beams. No deterioration noted. Considered a lifetime component so no funding required. The structural framework of the building comprises load-bearing cast-in-place concrete elements with reinforced concrete decks supported by concrete shear walls and columns. The exterior walls consist of stucco-covered concrete masonry unit (CMU) block infill. This type of structural system typically has a lifespan of 100 years or more with proper maintenance and repair.

Over time, localized deterioration is common, requiring periodic maintenance. During our site visits, no significant damage or deterioration was observed. However, minor hairline cracking was noted on the exterior of the lake building. To address ongoing maintenance needs, a reserve fund has been included for periodic repairs to the cast-in-place concrete structural elements.

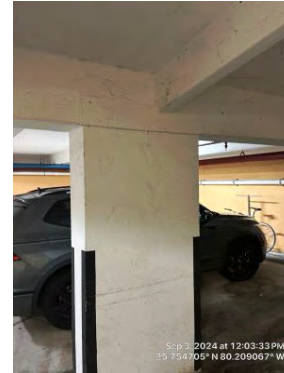
| Location | Desc. | Condition | Service Date | Replace Date | Rem Life | Adj Life | Quantity | Current Cost | Future Cost |
|---|---|---|---|---|---|---|---|---|---|
| Garage | | Good | 07/01/2009 | 07/01/2059 | 34:06 | 50:00 | 1 | 10,000.00 | 32,767.41 |

The structural framework of the building comprises load-bearing cast-in-place concrete elements with reinforced concrete decks supported by concrete shear walls and columns. The exterior walls consist of stucco-covered concrete masonry unit (CMU) block infill. This type of structural system typically has a lifespan of 100 years or more with proper maintenance and repair.

Over time, localized deterioration is common, requiring periodic maintenance. During our site visits, no significant damage or deterioration was observed. However, minor hairline cracking was noted on the exterior of the lake building. To address ongoing maintenance needs, a reserve fund has been included for periodic repairs to the cast-in-place concrete structural elements.

Repair allowance for concrete
