**STRUCTURAL INTEGRITY
RESERVE STUDY
30-Year Projection
Beginning January 1, 2025**

Example SIRS Report

01 - Example SIRS Report
January 1, 2025

SIRS Report Introduction
Structural Integrity Reserve Study (SIRS)

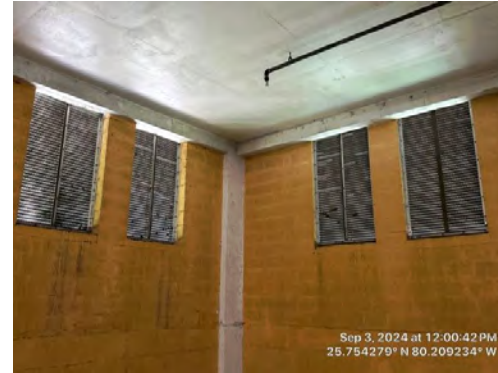
Vent Covers Painting - The vents were last painted in 2009, and the existing paint was observed to be in poor overall condition during our on-site analysis, and rust had started to accumulate. A full exterior painting, including vents, is scheduled for June 2025. It is recommended that exterior metal surfaces be repainted every 7 to 10 years due to environmental factors.

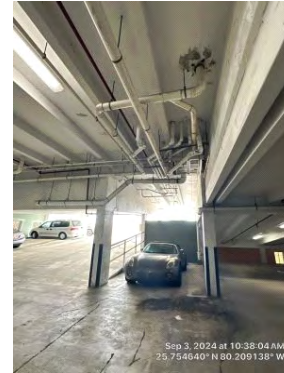
Potable Water Lines - Based on our experience, main potable water lines typically have a lifespan of 50 to 70 years with routine maintenance. Repairs or replacement of these lines are generally performed on an as-needed basis as part of normal building maintenance.

Sanitary Lines - Sanitary stacks, including vertical laundry, kitchen, and sewer pipes, occasionally accumulate debris and require regular servicing. Over time, these stacks can deteriorate to the extent that lining or replacement becomes necessary. With routine maintenance and cleaning, sanitary stacks generally have a lifespan exceeding 50 years. A reserve fund has been established to cover periodic inspections, cleaning, and the replacement or relining of the sanitary stack lines as needed.

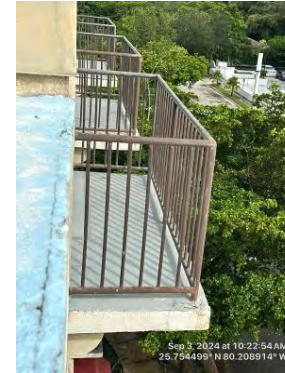
Railings - Replace

Balcony aluminum railings - The railings are attached to the structures with fasteners penetrating through the waterproofing and into the structural concrete decks. As these types of rails age, they offer one of the greatest potentials for moisture entry into the structural slabs. Therefore, we believe these components must be properly maintained to prevent potential damage to the structure. Also, maintenance of these items is a significant life safety item because of their fall-protection aspect. Aluminum railings have a typical useful life of 30-years with routine maintenance. A reserve for replacement of the railings has been included. Replace as necessary - Cost includes installation

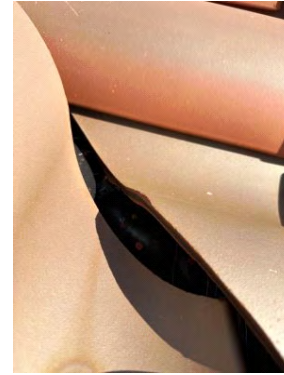
Roof Repairs - One Time

Allowance for immediate repair of tile roofing to repair flashing and improperly installed roof cap.

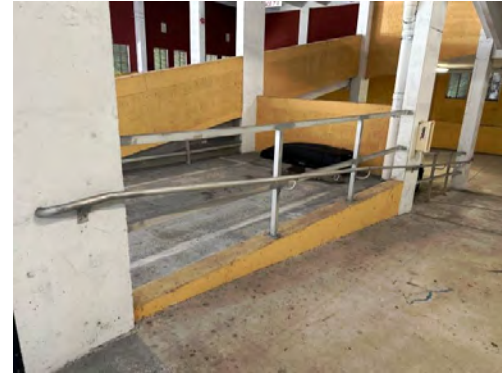
Garage Floor Sealant - The garage floor was last re-sealed in 2009. Garage floors were observed to be in good overall condition during our on-site analysis. It is recommended that garage floors be re-sealed on a 7 to 10 years cycle.

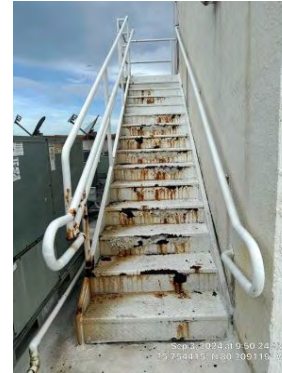
Currently considered a safety hazard, replace immediately. Exterior metal stairs are used on the roof to access the elevator equipment room. They are commonly used due to their strength, longevity, and low maintenance. The exterior metal stairs are stair systems made of steel and while normally long lasting, these stairs have suffered severe rust damage because of not being regularly painted. Given the humid climate and proximity to the coast these stairs should be painted regularly to minimize rust. Steel stairs require proper coatings or treatments to avoid rust in wet or coastal areas.
